Illicit Discharge Detection in Richmond, Waterbury, Moretown, and Waitsfield

FINAL REPORT

January 24, 2011

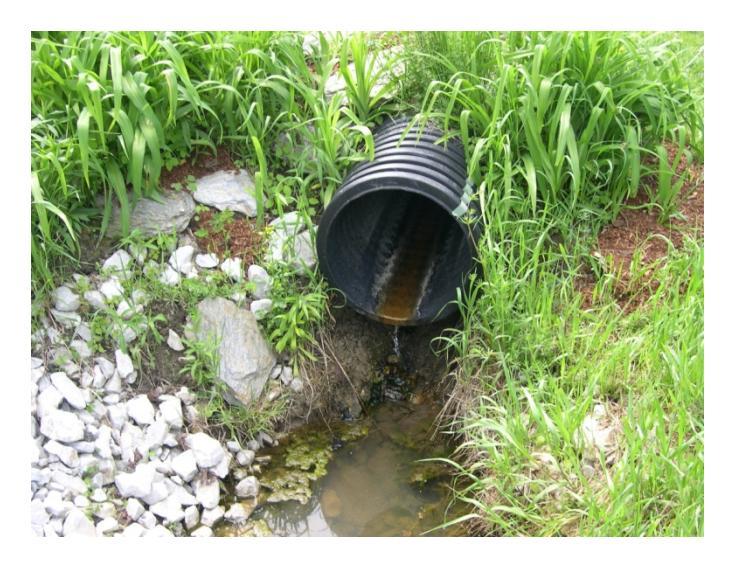
Outfall RI-003 is the discharge point for the storm sewer at the Richmond town garage (see Figure 2). As illustrated in the photograph below, this outfall is an 18-inch diameter corrugated black plastic pipe with a persistent trickle of flow in dry weather. This system was investigated in detail after optical brightener was detected and exceedingly high specific conductance (6,280 µS/cm) was measured in the initial assessment. Suds and some iron staining were observed at the outfall. Analytical data collected at this outfall are summarized in Table 4; the data in bold face are concerning.

Outfall RI-003 from the Richmond Town Garage

Subsequent to the July 1, 2010 investigation, we suspected two problems contributing to poor water quality at the RI-003 outfall: seepage of petroleum and possibly metals contaminated groundwater to the structures on the backside of the garage and also a wastewater source arising somewhere on the property. The Richmond Town Garage is a listed contaminated site due to historic petroleum releases (from failed fuel tanks and purportedly a waste dumping area). Road salt has also been stored on the property. We attributed the high specific conductance values to salt and/or metals contamination of groundwater arising from these past uses.

have on petroleum contamination of the storm sewer is unknown, but it should improve water quality over the long term. The town garage is a recognized contaminated site and the responsibility of the Town of Richmond (with oversight by the DEC Sites Management Section). The only recommendation we make is that outfall RI-003 be tested periodically to confirm reduction in petroleum contamination. Therefore, the outfall is included on the Watch List in Table 3

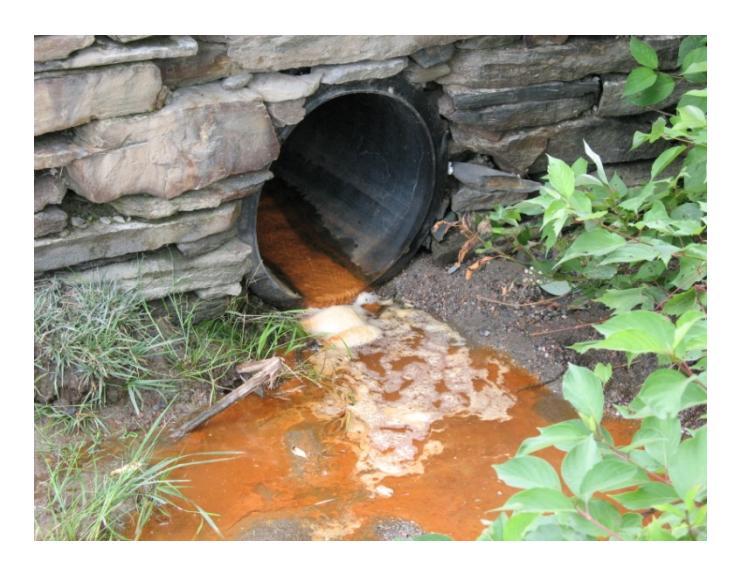
Outfalls WB-460/WB-470

Two flowing pipes, WB-460 and WB-470, were assessed at the Ben and Jerry's factory property on July 8, 2010 (see Figure 6). The photograph below was taken at WB-470, where flow enters the stormwater pond. During the initial assessment on July 8, 2010, the ammonia concentration and the specific conductance were elevated at outfall WB-460 and the fluoride and specific conductance were elevated at outfall WB-460 and the fluoride and specific conductance were elevated at outfall WB-470. These data are included in Appendix B and summarized in Table 9; the data in bold face are concerning. Iron staining was observed at both outfalls. Optical brightener was not detected at either outfall. Follow-up sampling on July 28, 2010 at WB-460 yielded a higher ammonia concentration (1.0 mg/L), high specific conductance, and fluoride. At WB-470, ammonia, specific conductance, and fluoride were somewhat lower than on July 8. *E. coli* and total phosphorus concentrations were very low at both outfalls on July 28, 2010.

Outfall WB-470

Based on the statements and testing of Mr. Thompson and on our observations, we do not believe that there is an illicit discharge problem at the facility. The iron staining is a likely consequence of groundwater discharge from the fill slope; the pulsing flow was simply a misleading observation; the low ammonia levels may result from decomposition of organic nitrogen under reducing conditions in the saturated swales; and the fluoride may result from use of municipal drinking water for cleaning the Scoop Shop patio and other public areas. The foam observed on July 8 at WB-470 is a little more puzzling; however, organic acids leached from vegetation can cause foaming in natural waters and perhaps that is all that is occurring here.

While a reasonable explanation may be found for all the observations and water quality results, it is prudent to repeat sampling periodically to rule out the possibility that we have missed something significant. Both WB-460 and WB-470 are included on the Watch List in Table 3.

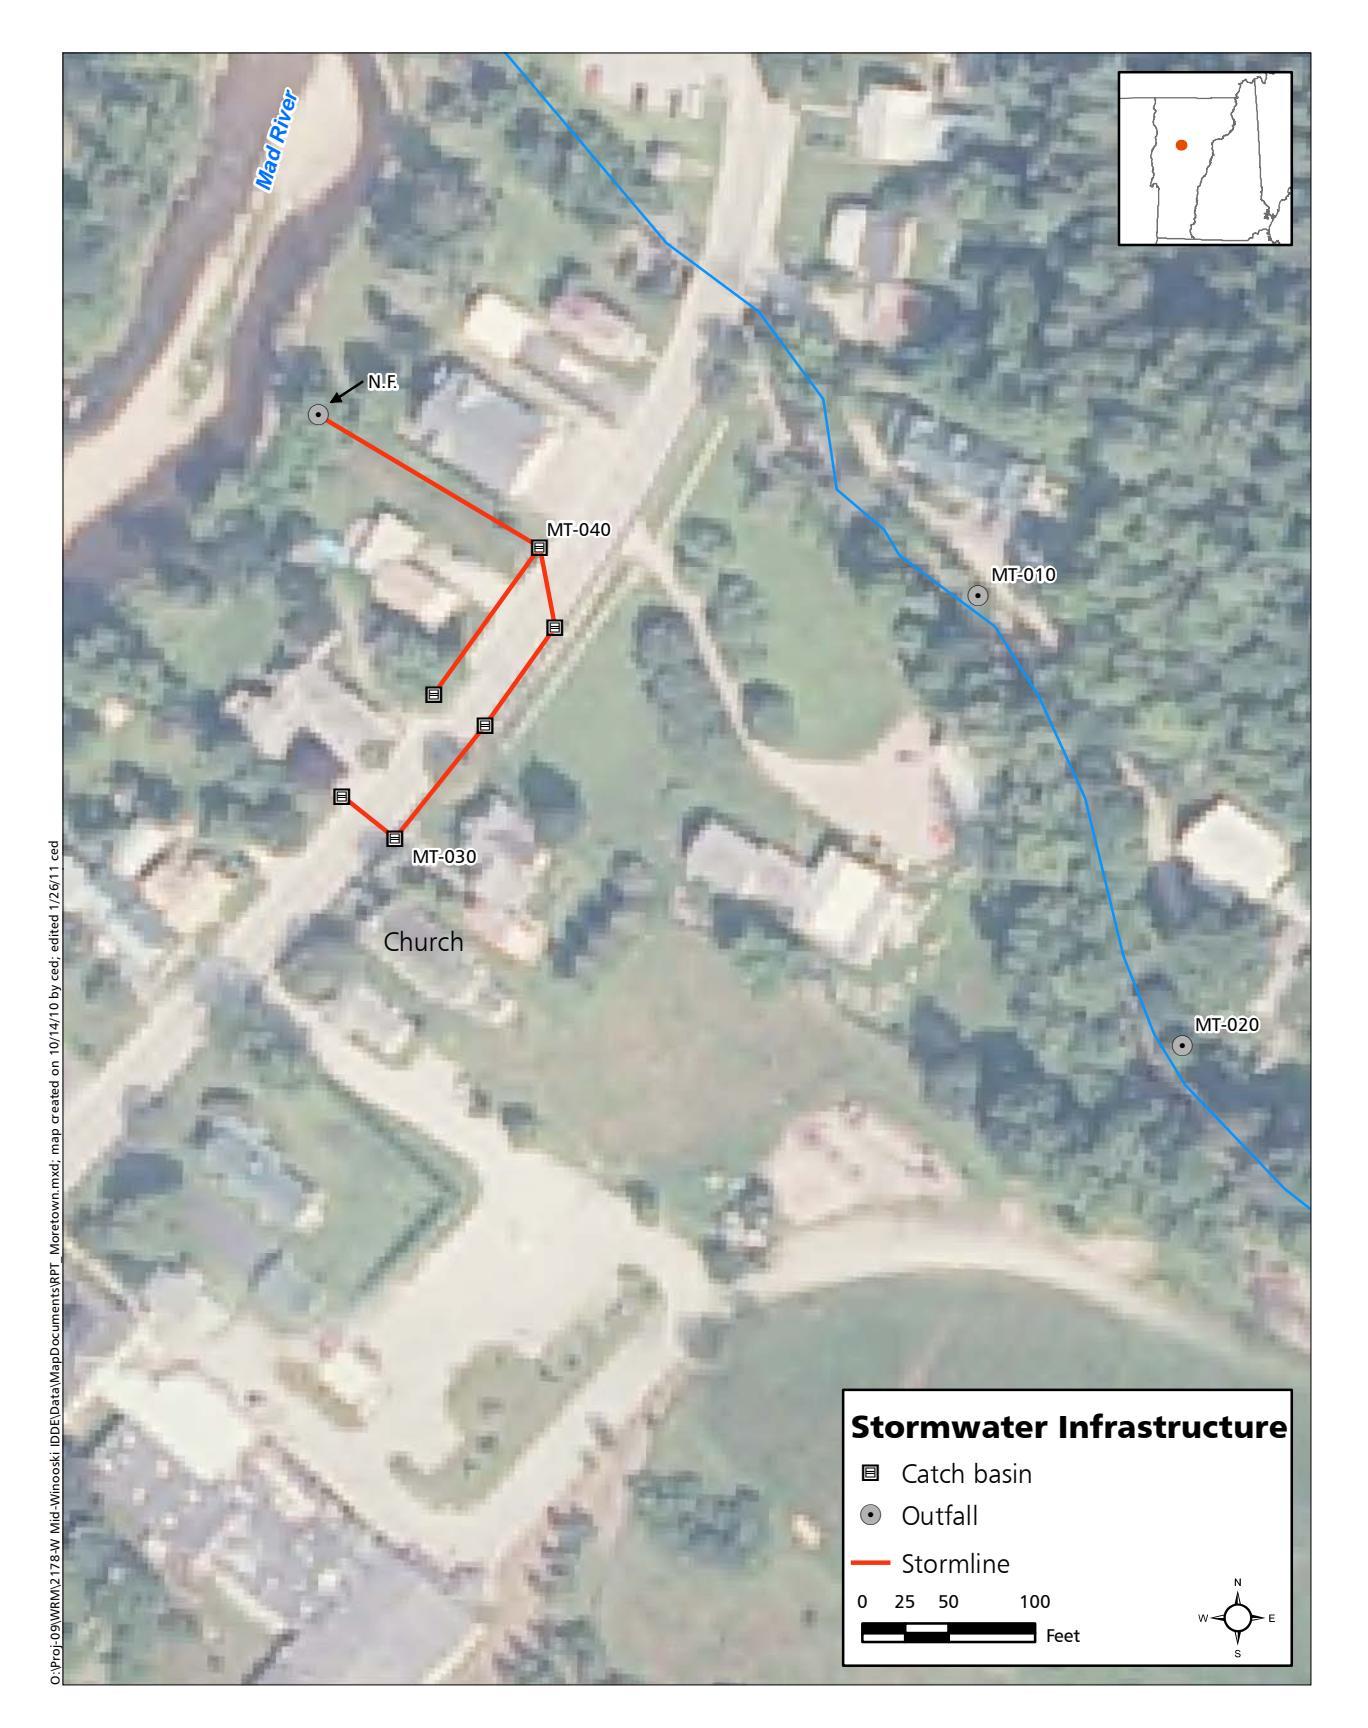
Figure 7. Moretown Illicit Discharge Assessment Mid-Winooski IDDE

The only potential problem identified in Moretown was a pipe discharging in the area of MT-030 that appears to be the outlet for a sump pump located in the church building (see Figure 7), although this was not confirmed. This pipe was not flowing when observed. Therefore, the only recommendation FWR and FMR will make in the final letter to Moretown is to advise the town to check in the church building for any improper plumbing connections to this pipe.
