Illicit Discharge Detection in Richmond, Waterbury, Moretown, and Waitsfield

FINAL REPORT

January 24, 2011

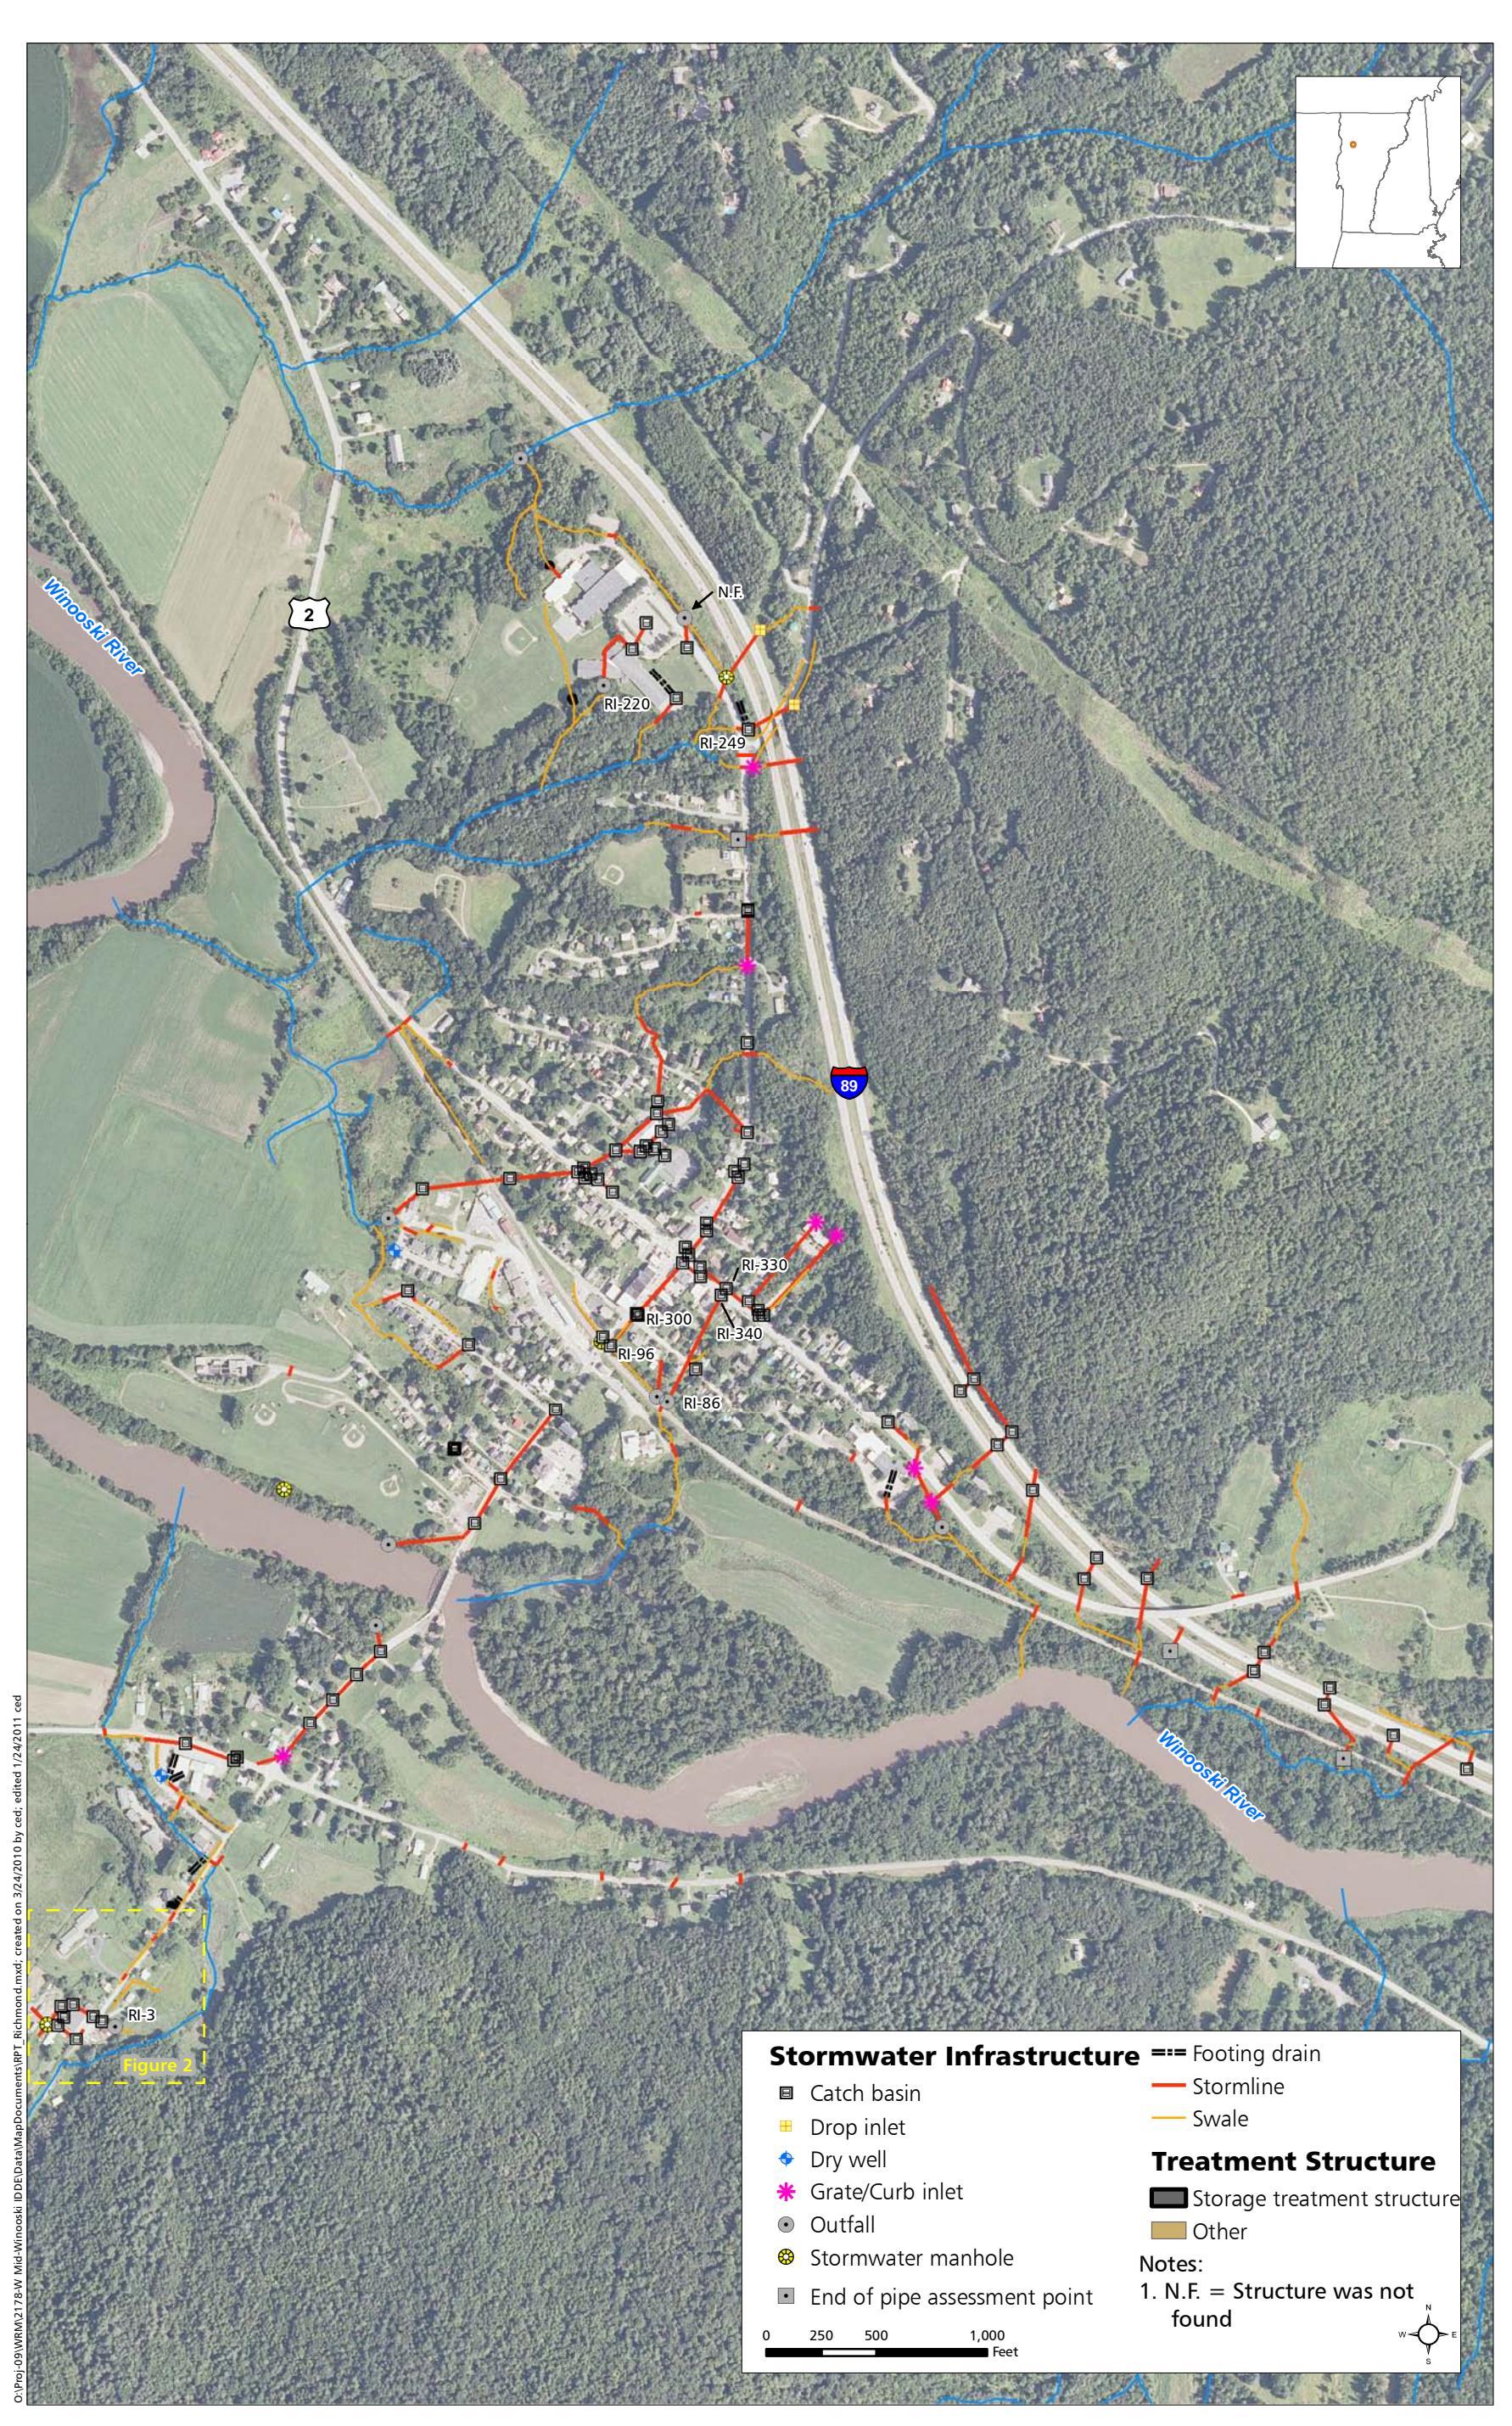
Figure 1. Richmond Illicit Discharge Assessment Mid-Winooski IDDE

Catchbasin RI-096 is the terminal catchbasin on the storm sewer running up Bridge Street to the intersection of Route 2 (Figure 1). This catchbasin discharges via an outfall to a ditch adjacent to and upslope of the railroad tracks. During the initial assessment and four subsequent visits, this outfall was

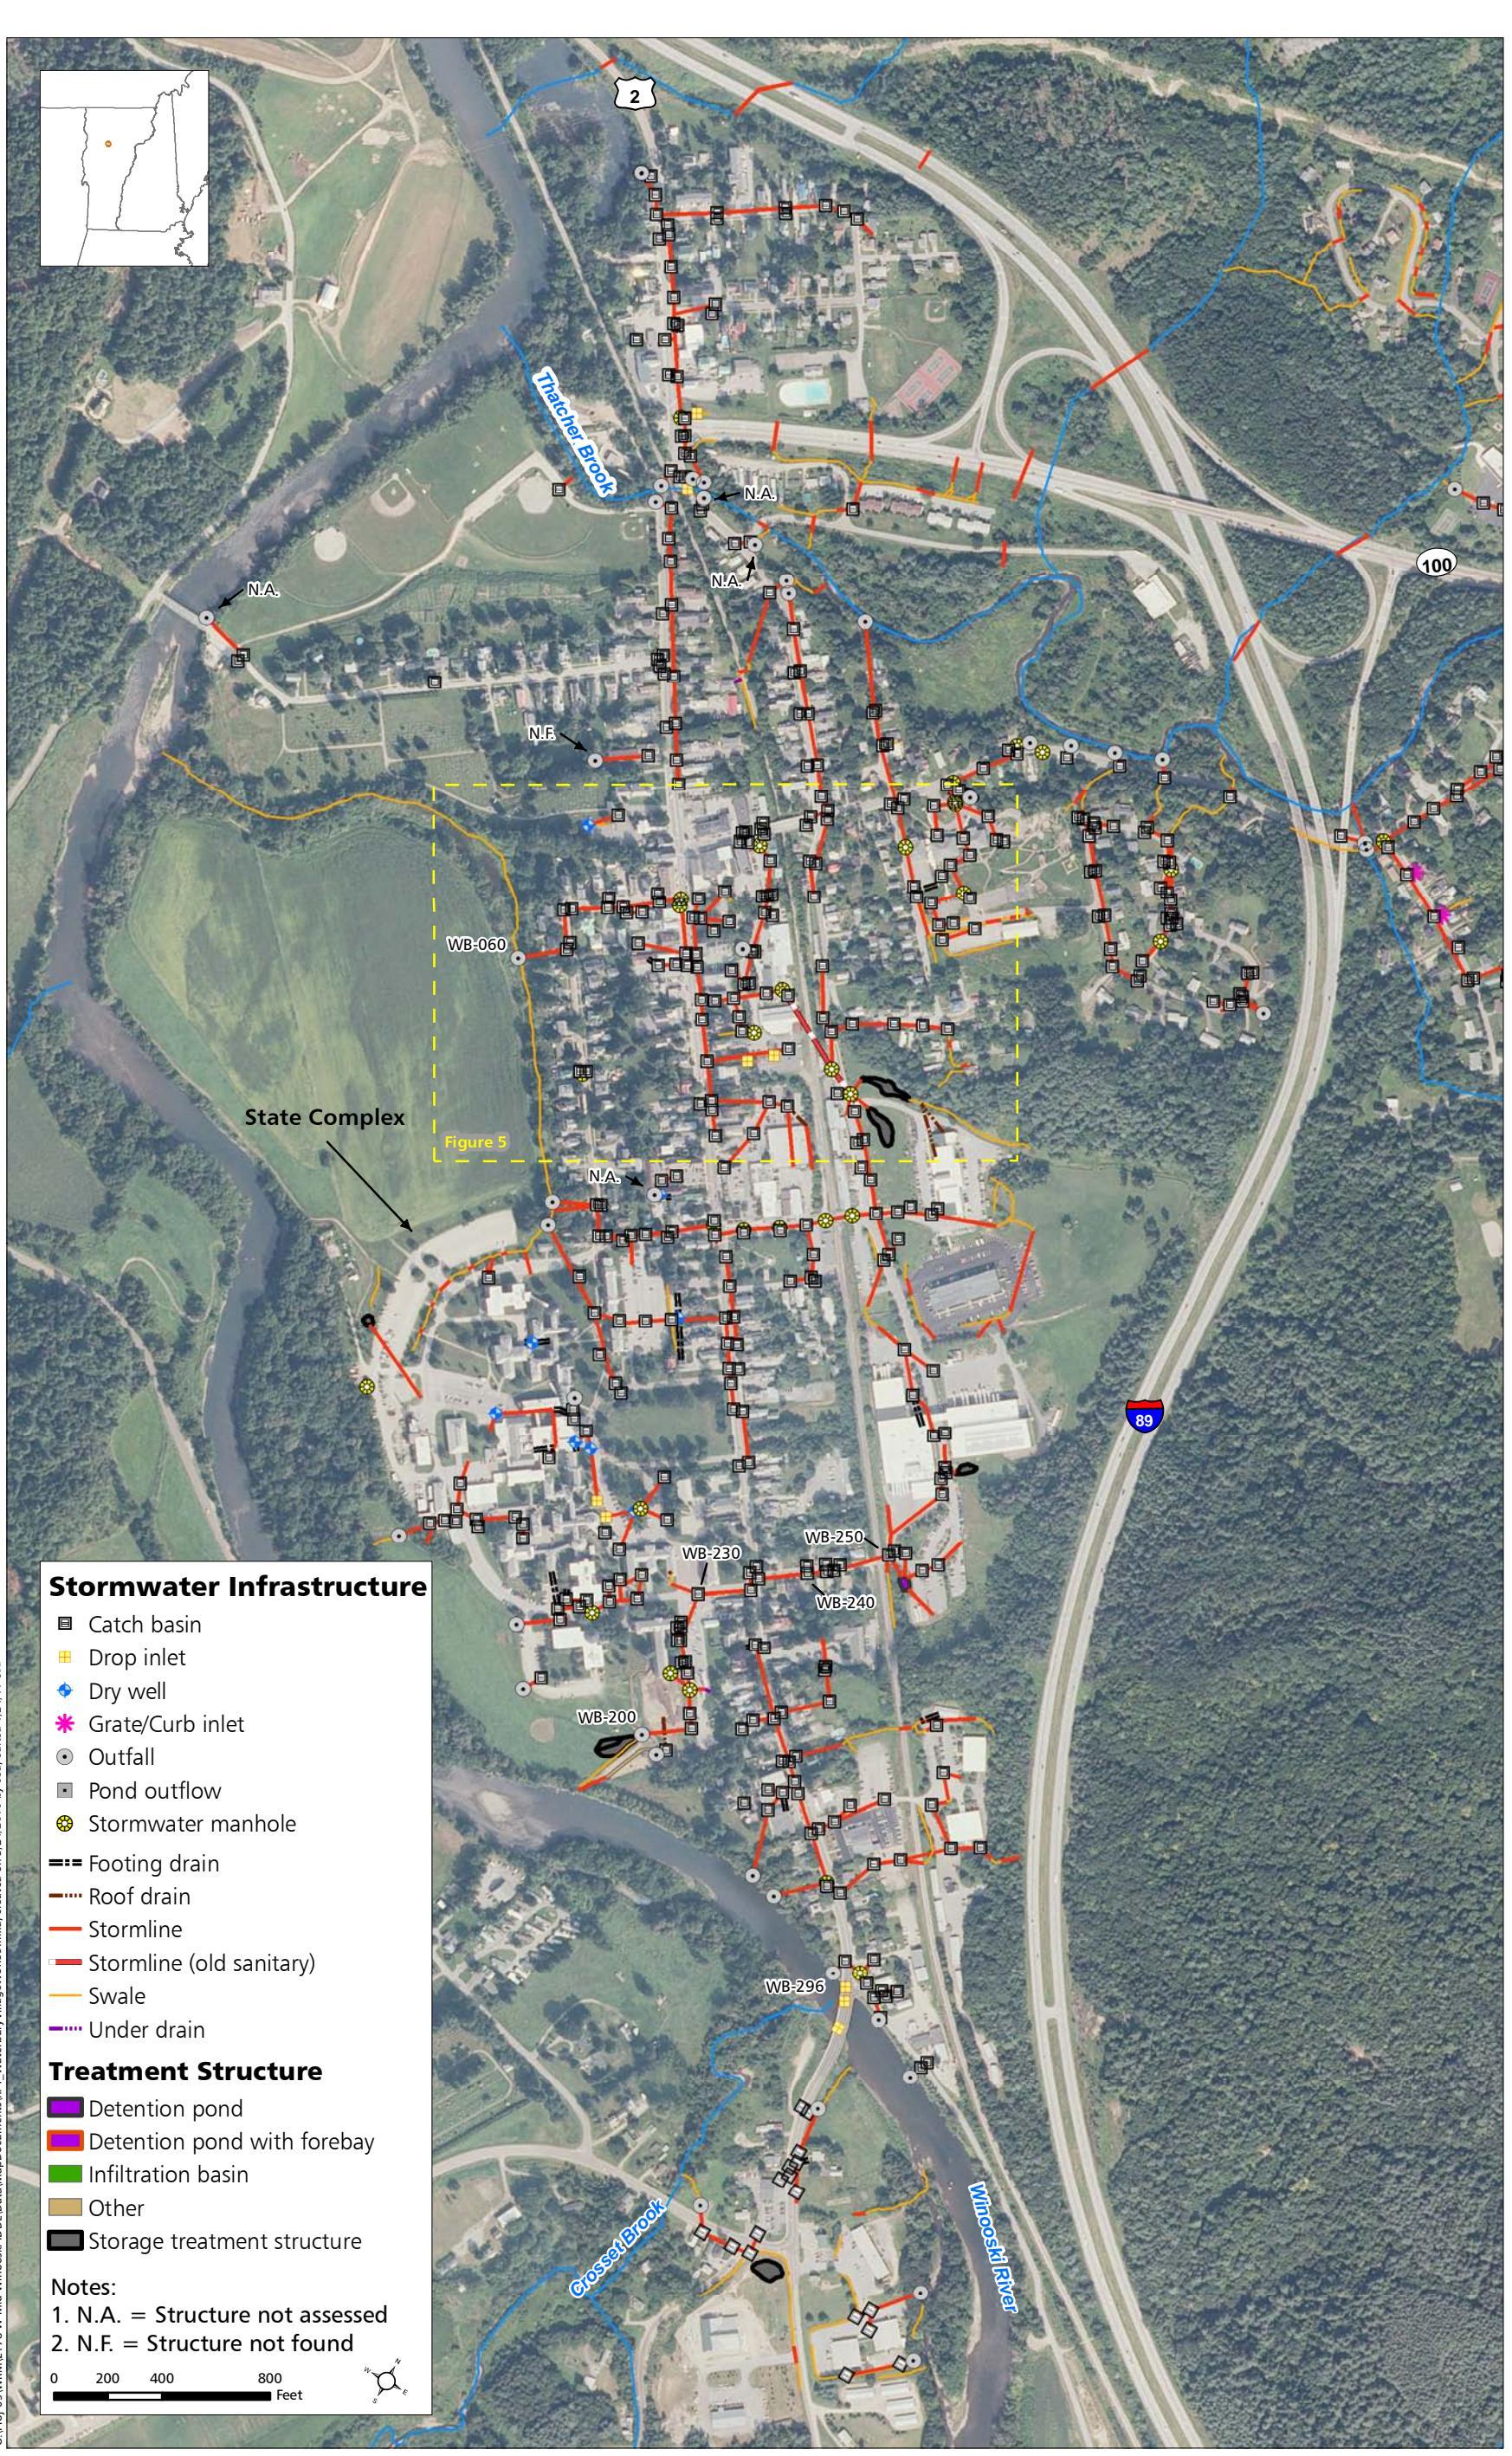
Figure 3. Waterbury (West of I-89) Illicit Discharge Assessment Mid-Winooski IDDE

Outfall WB-296 is the discharge point for a small storm sewer located immediately north of the Route 2 bridge over the Winooski River (see Figure 3). The outfall was dripping when assessed on July 7, 2010 and had a low, but detectable, ammonia concentration of 0.25 mg/L. Optical brightener was not detected. The outfall was revisited on July 13 and July 28, 2010 and was dry on both occasions. Based on these results, we concluded that there is no illicit discharge to this system.

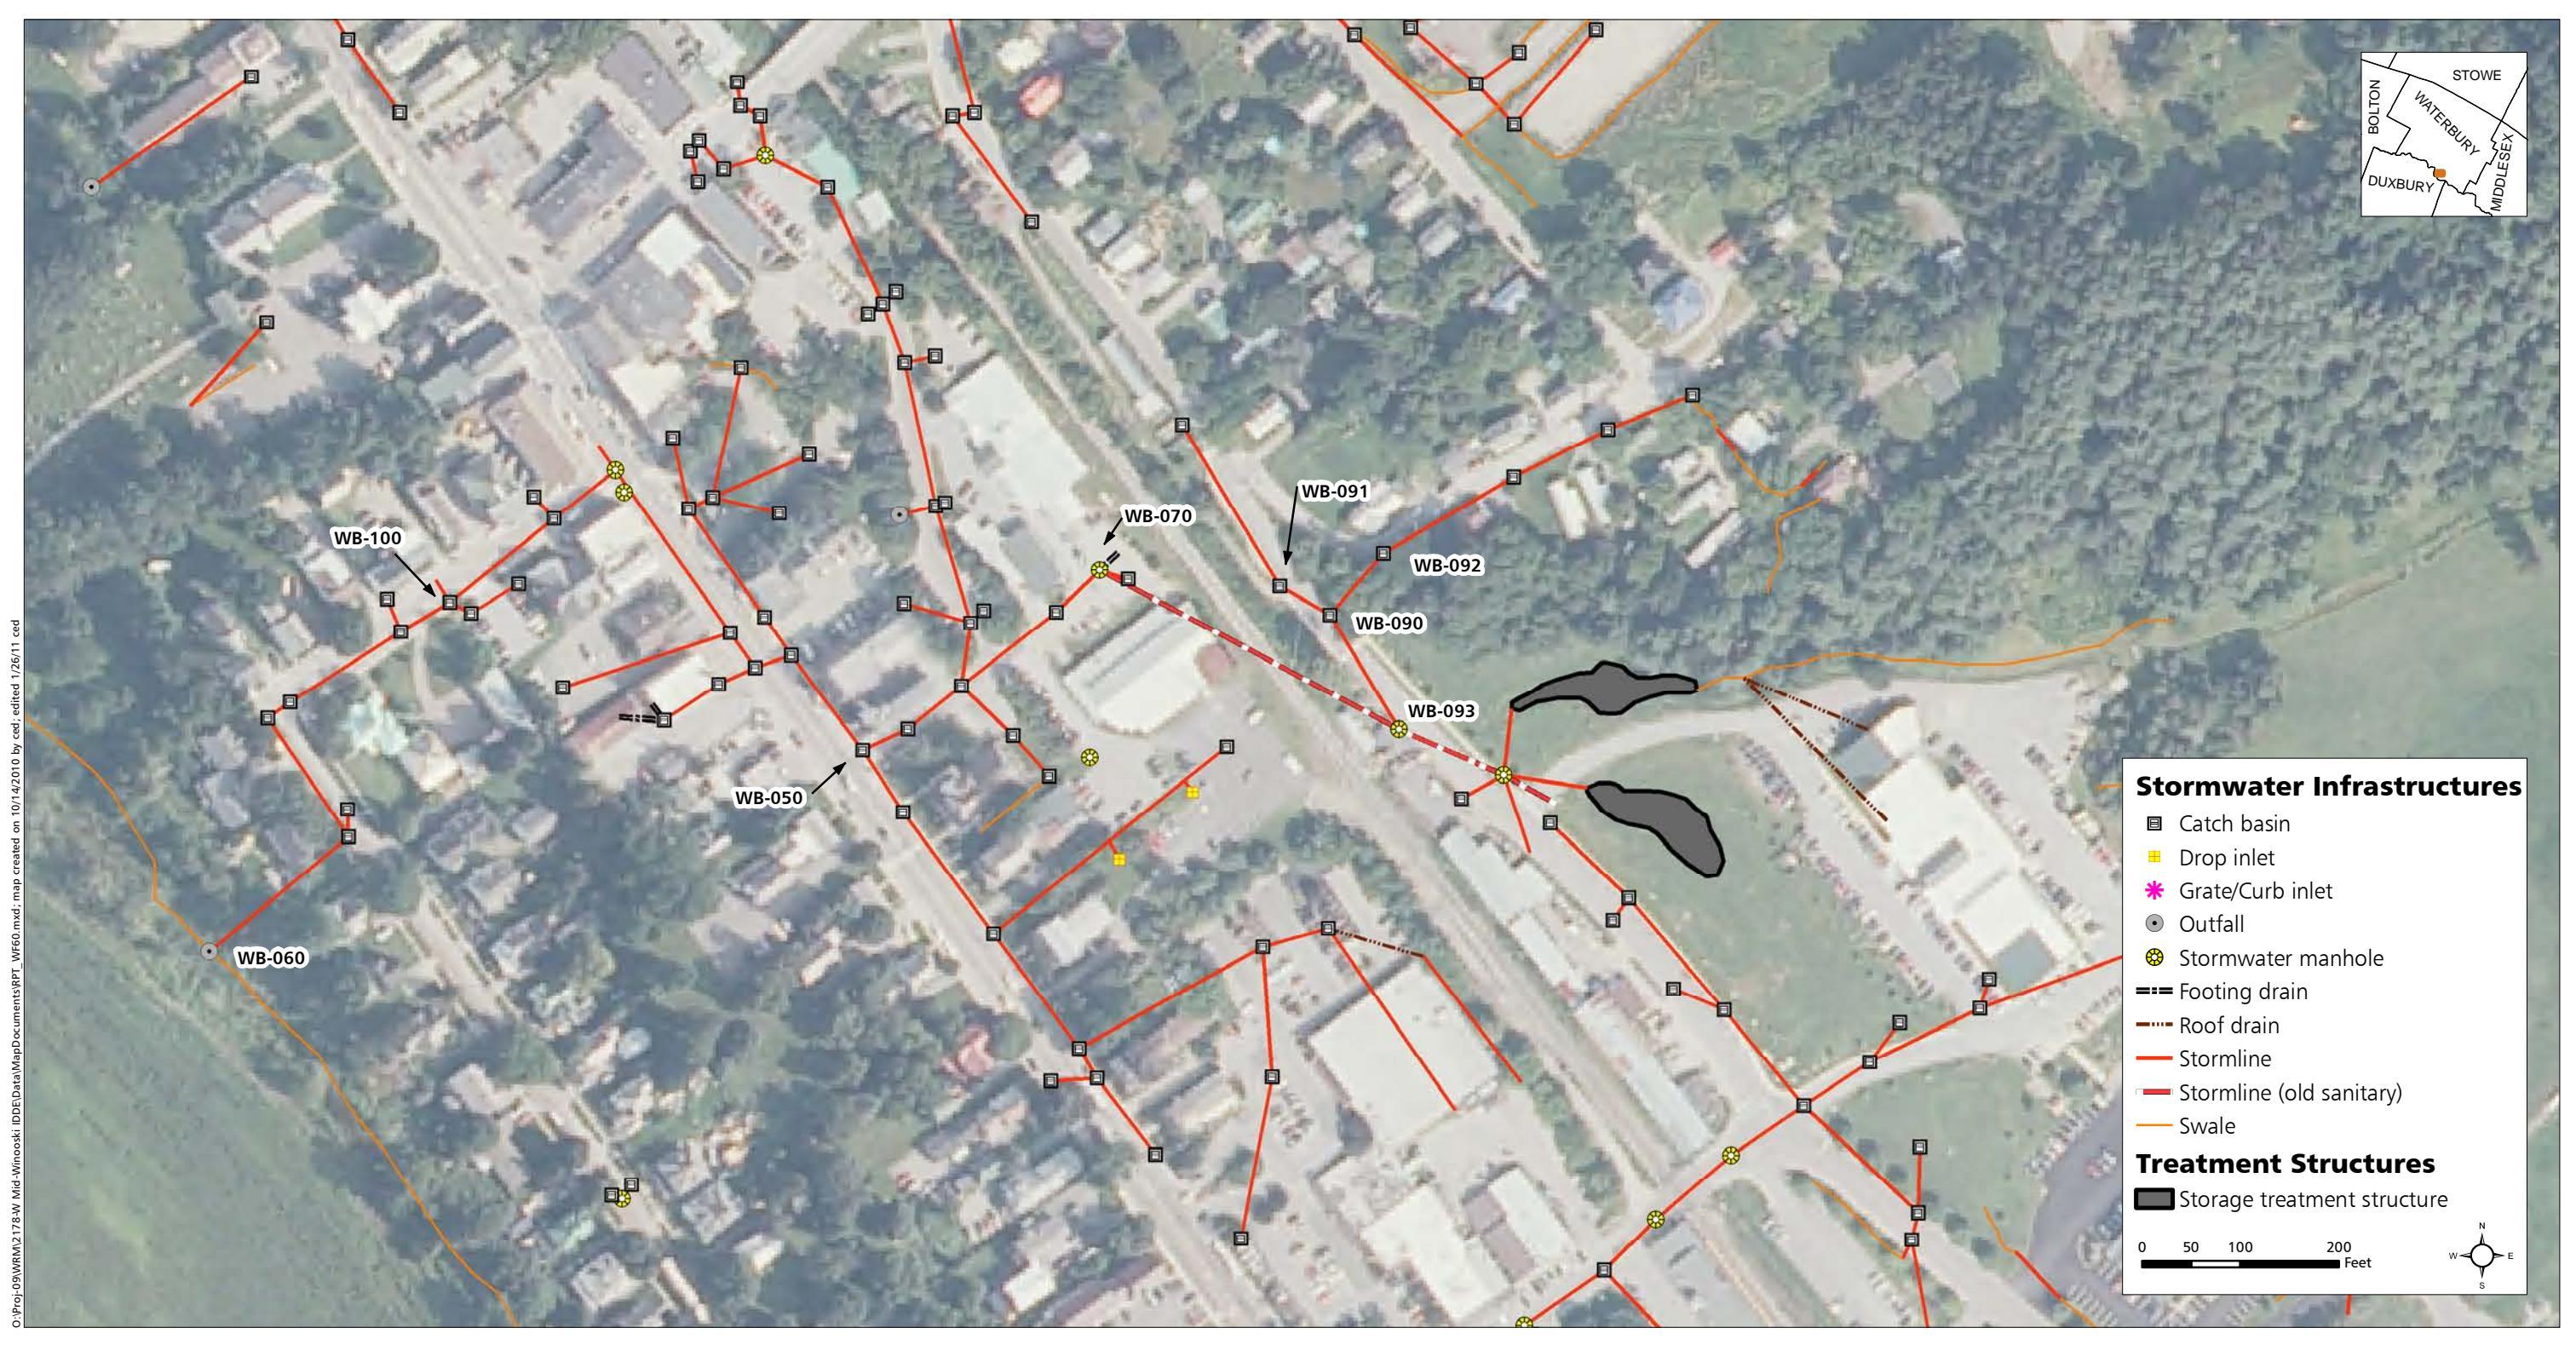
Figure 5. Waterbury WB-060 System Illicit Discharge Assessment Mid-Winooski IDDE

Outfall WB-060 is the discharge point for the most extensive storm sewer in Waterbury (Figure 5). It discharges to a swale on the backside of Randall Street. During the initial assessment, the optical brightener monitoring test was negative. However, water samples collected on July 6 had slightly elevated specific conductance and ammonia and fluoride concentrations. These data are presented in Table 7. In addition to the outfall, seven other structures in the WB-060 system were assessed on July 6 (manholes WB-050, WB-070, and WB-093 and catchbasins WB-090, WB-091, WB-092, and WB-100). There was negligible flow at WB-093 and the flow rate increased to WB-070. Specific conductance and ammonia and fluoride concentrations at WB-070 were similar to levels at the outfall. No structures were identified that had substantially higher concentrations of these constituents.

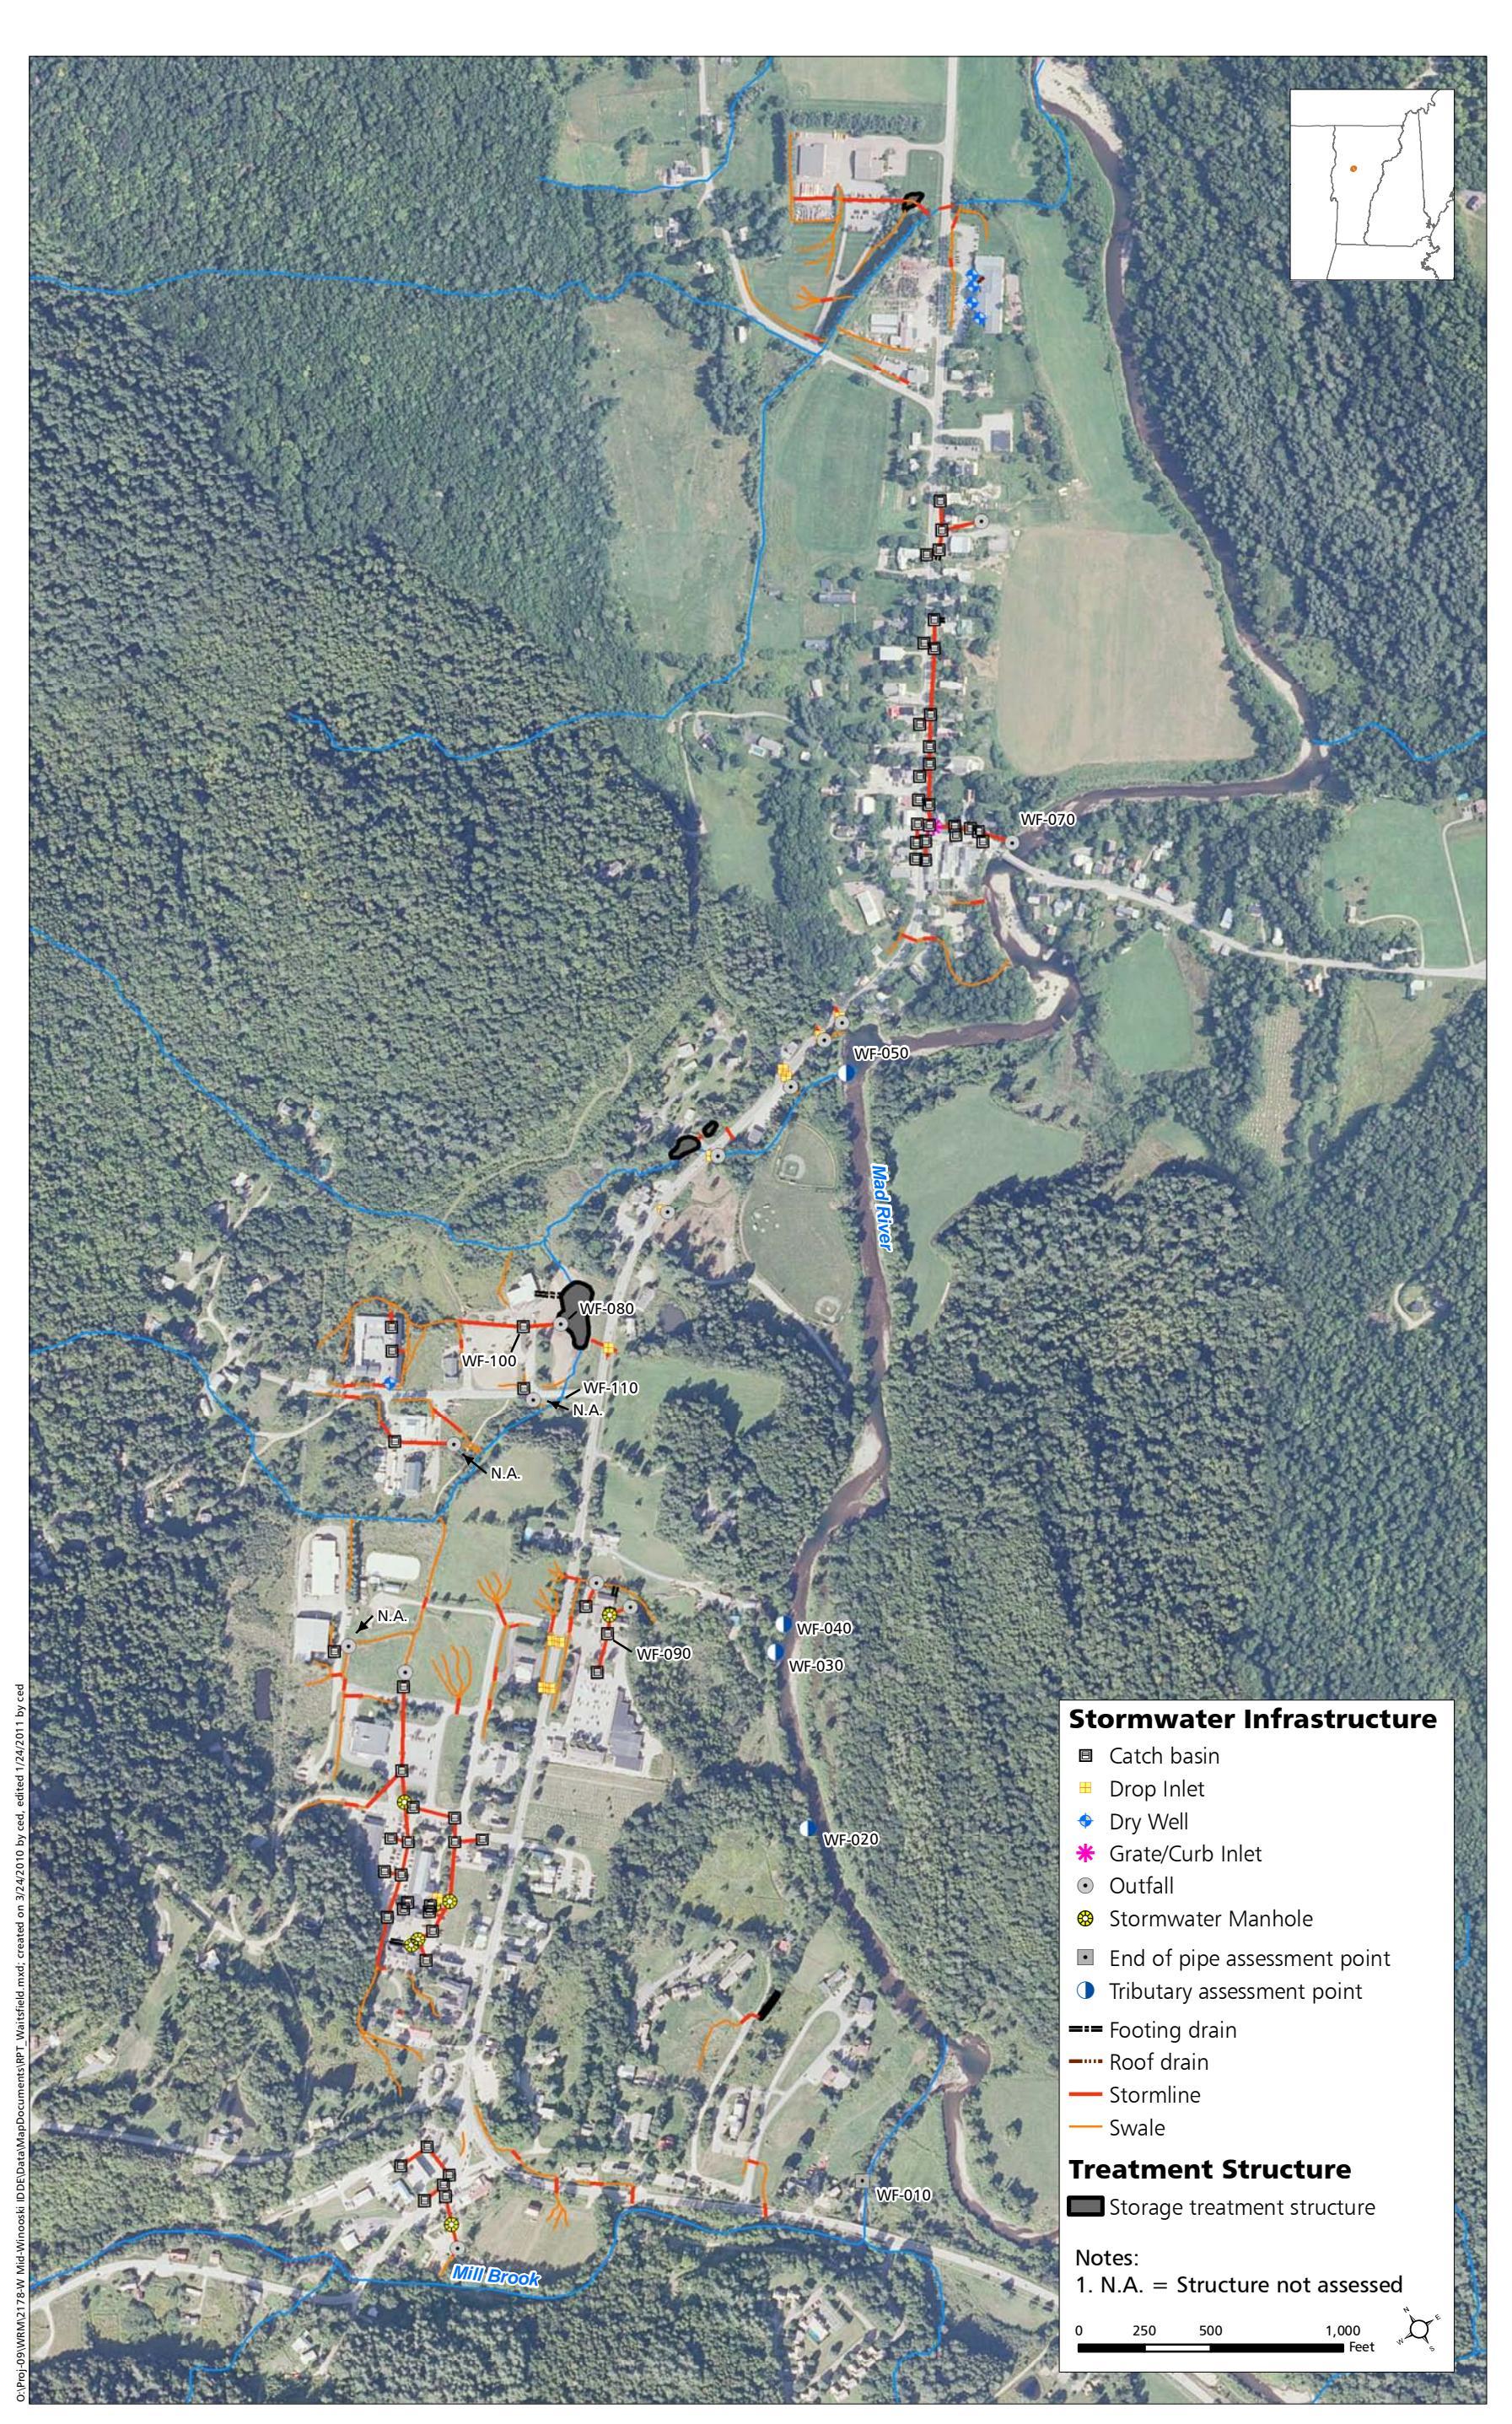
Figure 8. Waitsfield Illicit Discharge Assessment Mid-Winooski IDDE

Stormwater infrastructure mapped by DEC in Waitsfield is shown on Figure 8. On June 4, 2010 the municipal stormwater outfalls were assessed. Only two outfalls were identified as flowing during dry weather: WF-010, a 4-inch diameter pipe found to be dripping, and WF-080, an 18-inch diameter pipe flowing at a depth of approximately 1 inch. Iron staining was present at both WF-010 and WF-080, but
