Great Brook Fish Passage Restoration Project

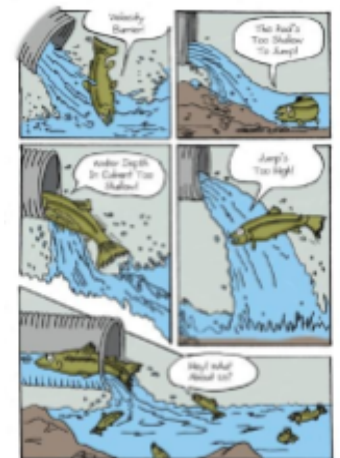
All three culverts along Great Brook were perched, undersized, and unpassable by aquatic species during most of the year. Each culvert had a deep depression or plunge pool on the downstream side that had gradually developed due to long-term stream incision and erosion from jetting flow. Improperly functioning culverts can prove disastrous for fish, wildlife, budgets, and public safety, especially in the event of flooding.

WSDOT-Redrawn from Fish Passage Short Course, John Runyon

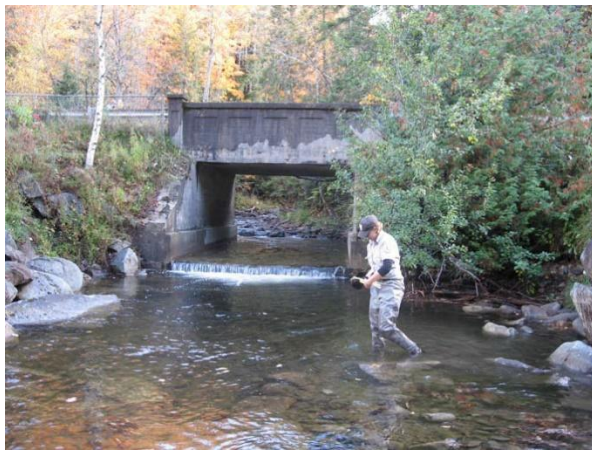
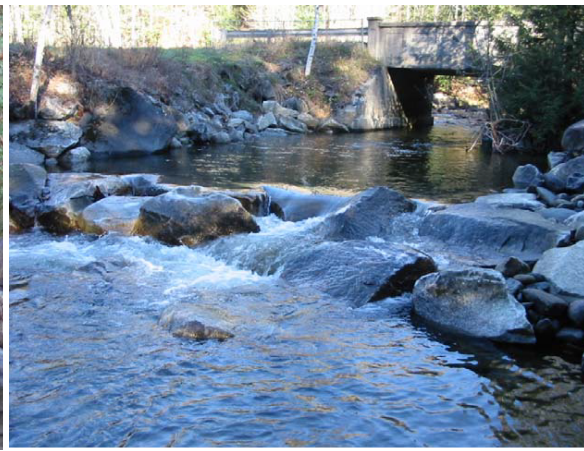
After Project

Observations from follow-up field trips in 2010 pointed to the early success of this project. Boulders and rock weirs were stable and passable through gaps in the rocks. Suitable fish passage conditions were achieved over a wide range of flows. Some fish were also observed in the culverts as well as upstream of the weirs. The culverts contained water (were backwatered) over almost all flow conditions leading to low water velocities, suitable water depths, and no outlet drops. Before and after photos of one of the culverts demonstrate a significant improvement in river flow and in fish passage potential.

implemented included: 1) increasing the tailwater control (the depth of water downstream) by using a rock weir (a cross-section of the stream filled in with stone); 2) roughening the stream channel with random boulders downstream of the rock weir; 3) filling the existing plunge pool with stone. The rock weir was the primary method of improving fish passage by reducing the downstream drop from the culvert (outlet drop), lowering water velocity, and increasing minimum depth of flow at each culvert.
